## MARSHALL MESA TRAILHEAD FIRE INVESTIGATION REPORT

File Name: Marshall Mesa Trailhead Fire  
Date of Incident: December 30, 2021  
Location: Intersection of Marshall Road (SH170), Eldorado Springs Drive, and Foothills Highway (SH93)  
JH File Number: 1A3894001

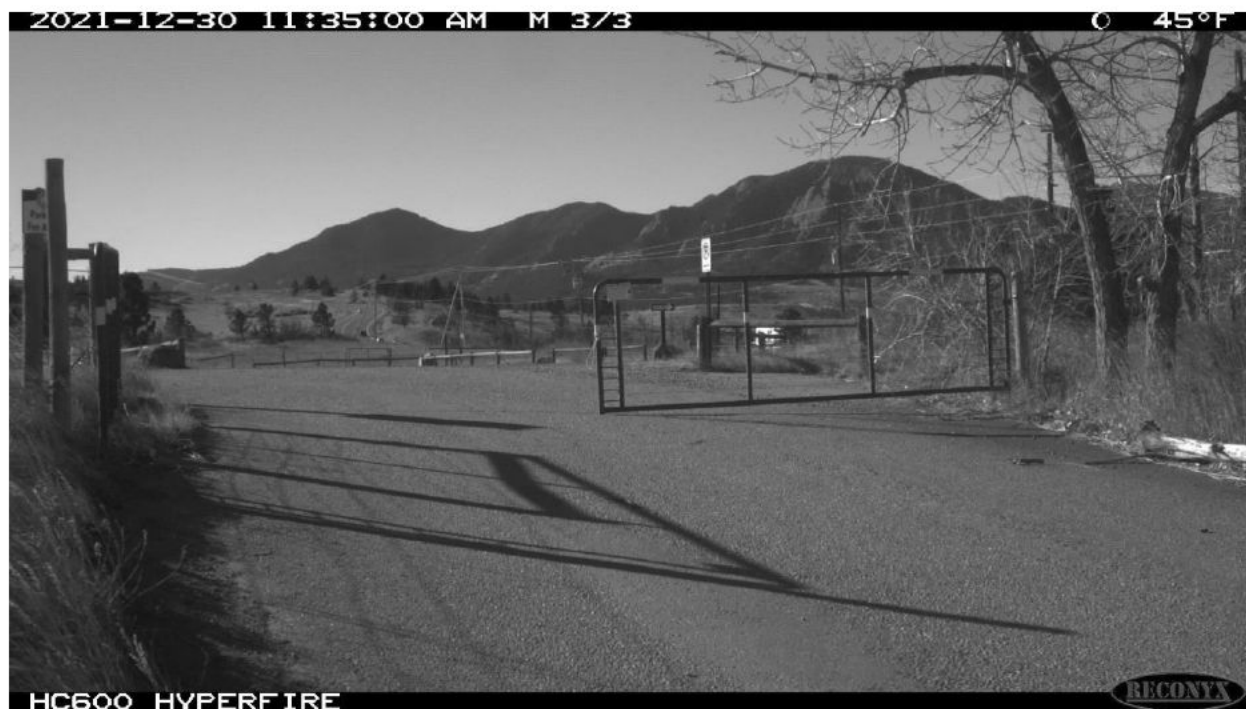
Figure 8. Gate Camera Pics 0810

12:17:05 pm<sup>5</sup> Gate Camera Pics, no fire recorded. Refer to Figure 8 and Figure 9  
12:20:00 pm Gate Camera Pics smoke plume visible. Refer to Figure 10 through Figure 12  
12:21 pm Mike Zoltowski video smoke plume present near MP2. Refer to Figure 14

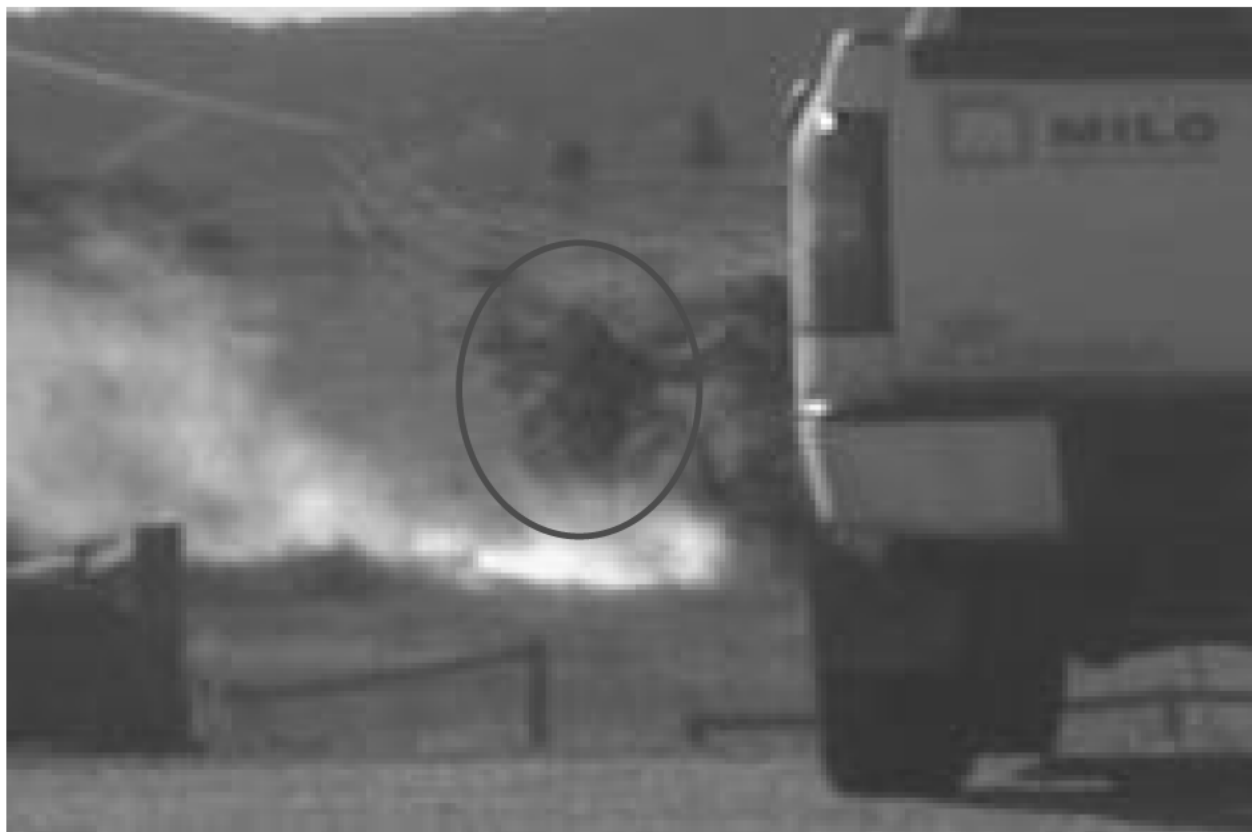
Circuit breaker 1161 opened and closed approximately 13 minutes before the smoke from the fire was first observed. The initial smoke plume and flames are in an area that matches the SAO #2 as shown in Figure 12 and Figure 13.

**Figure 12. Gate Camera Pics 0877 enlarged. Note the tree indicated by the red circle.**

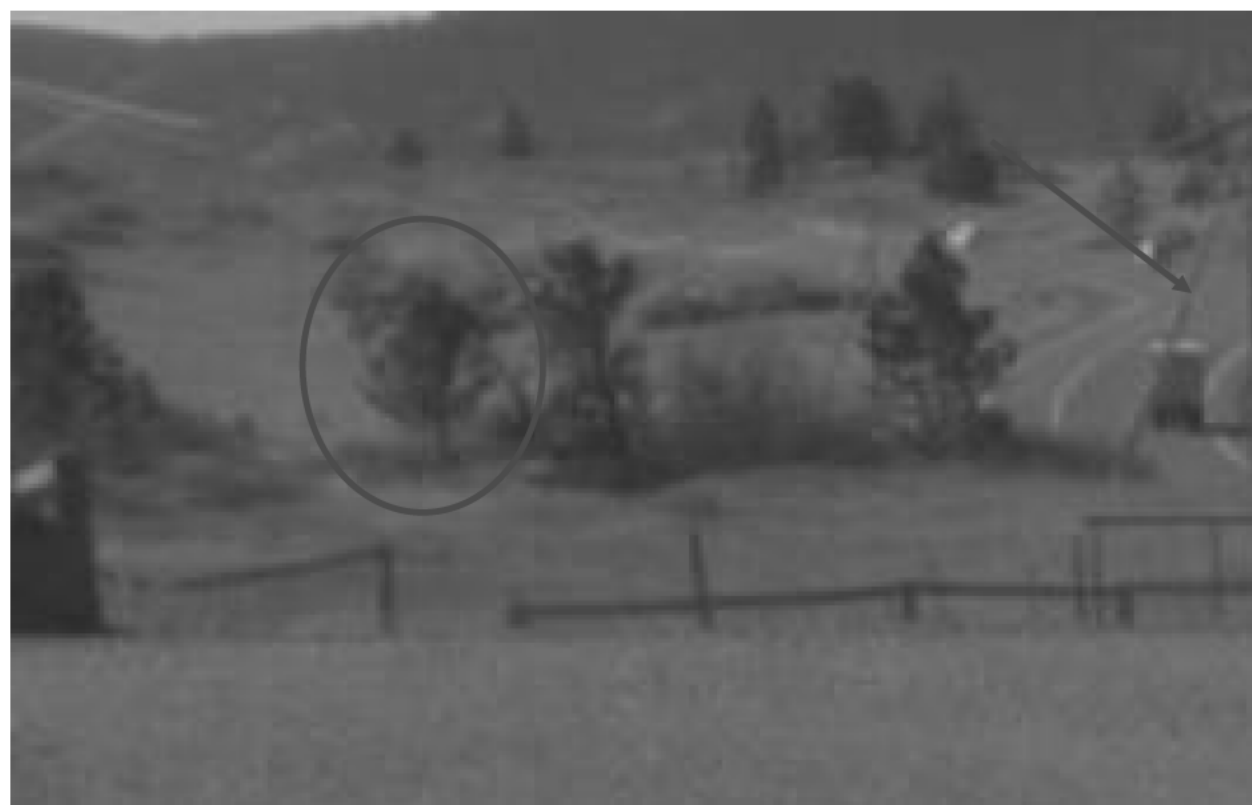
**Figure 13. Gate Camera Pics 0815 enlarged and lightened. Note the tree shown in Figure 12 is also circled in red. Also, Xcel Energy pole MP2 is indicated by the red arrow.**

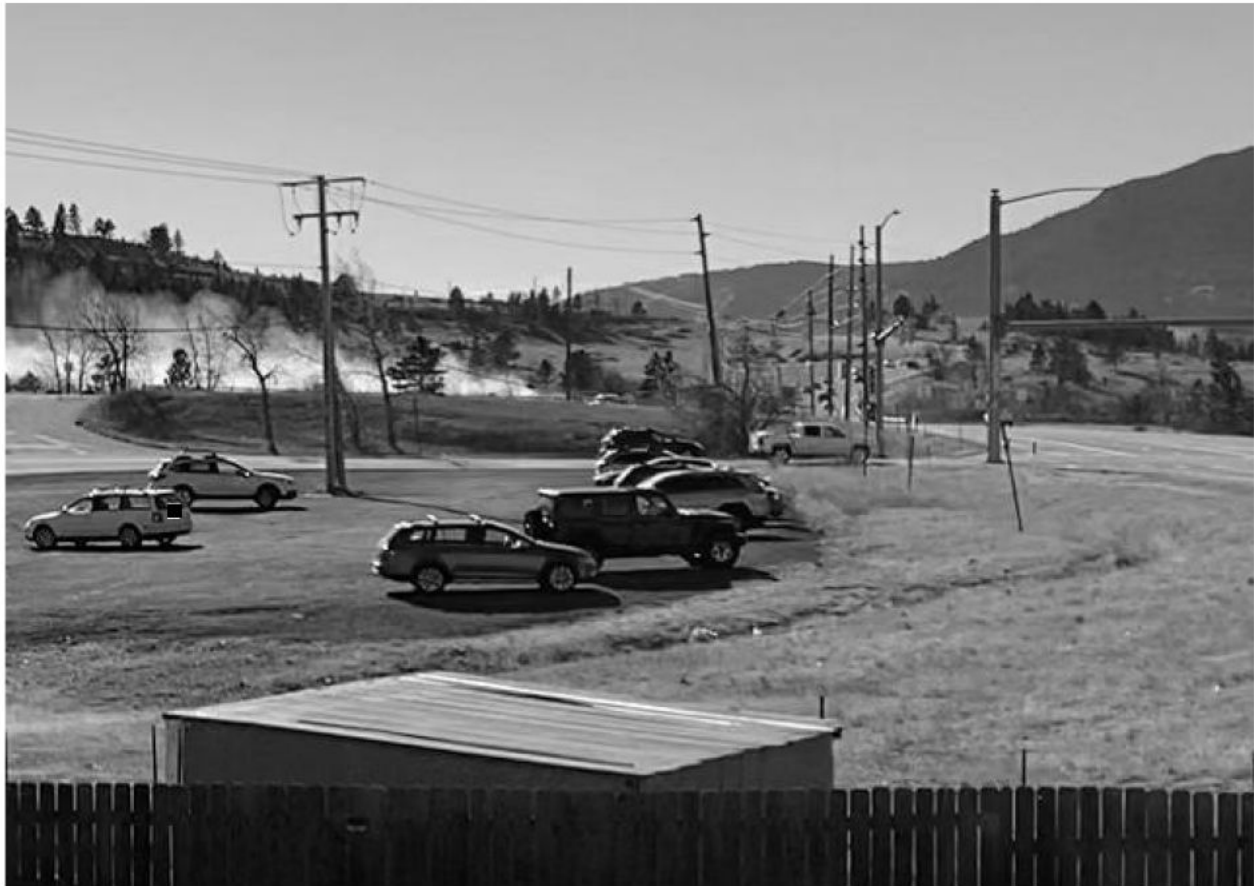
**Figure 14. 12:21 pm Mike Zolowski video smoke plume present near MP2.**

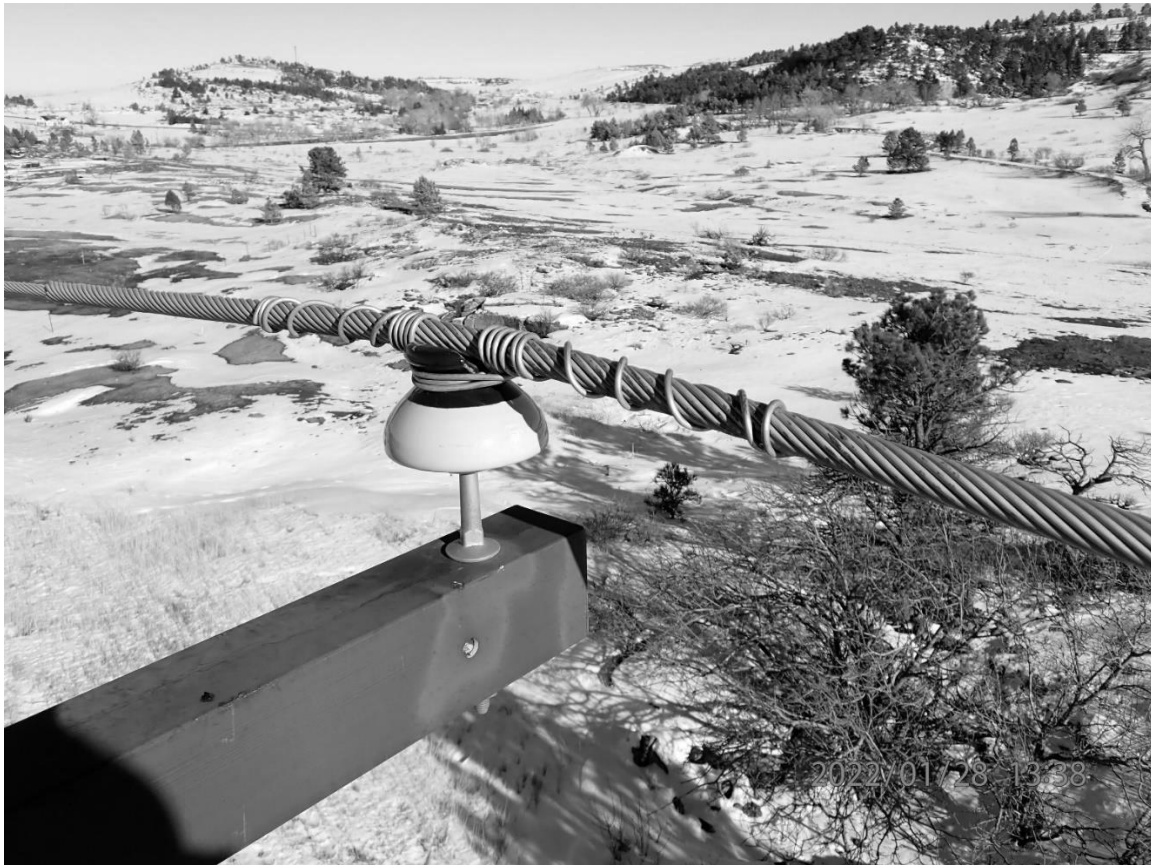
1. The fire in the area of the Marshall Mesa trailhead was ignited by hot aluminum particles produced when the east phase of Xcel Energy circuit 1161 came loose from its insulator and the lashing wire of the east phase contacted the center phase. The evidence examined revealed that the east phase had become detached from its insulator and that there was electrical arcing on the center phase conductor and on the lashing that had held the east phase to its insulator. The arcing on the east phase lashing and on the center phase conductor is conclusive evidence that the two conductors came into contact with each other and produced hot particles.

**Figure 20. East phase conductor. Note that the lashing on this conductor had degraded and failed at the time of the fire and allowed the conductor to become displaced from the insulator. The lashing on the conductor was replaced after the fire.**

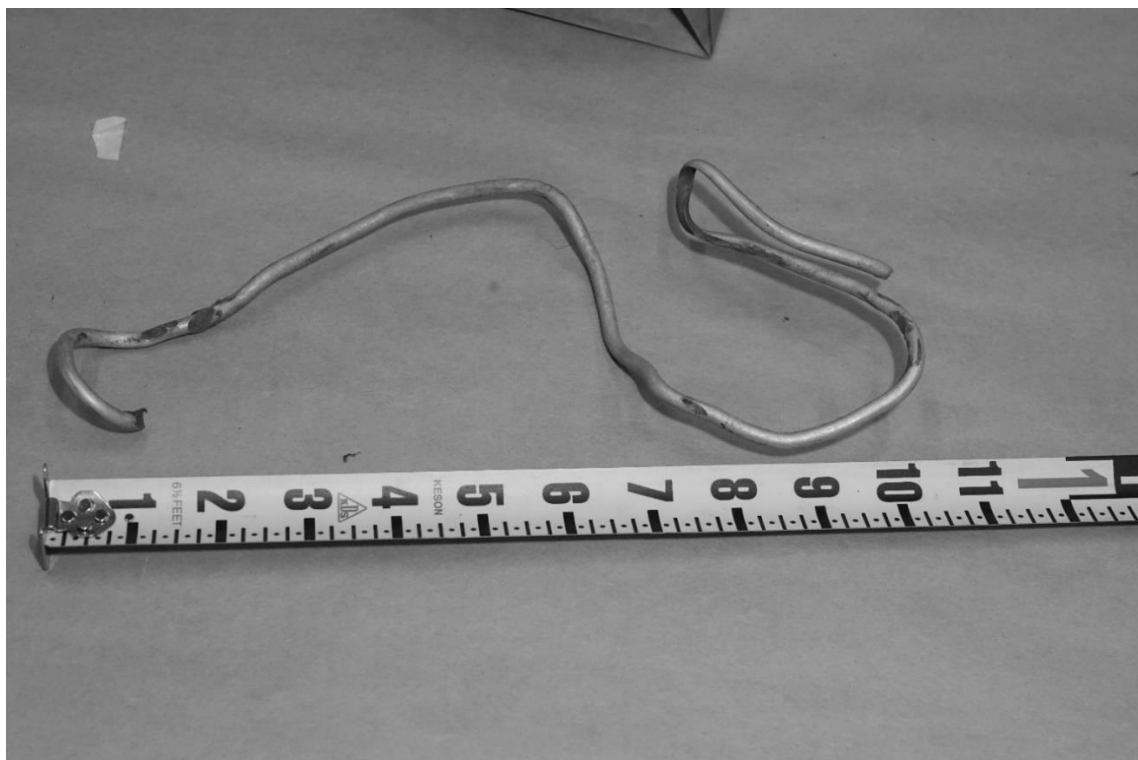
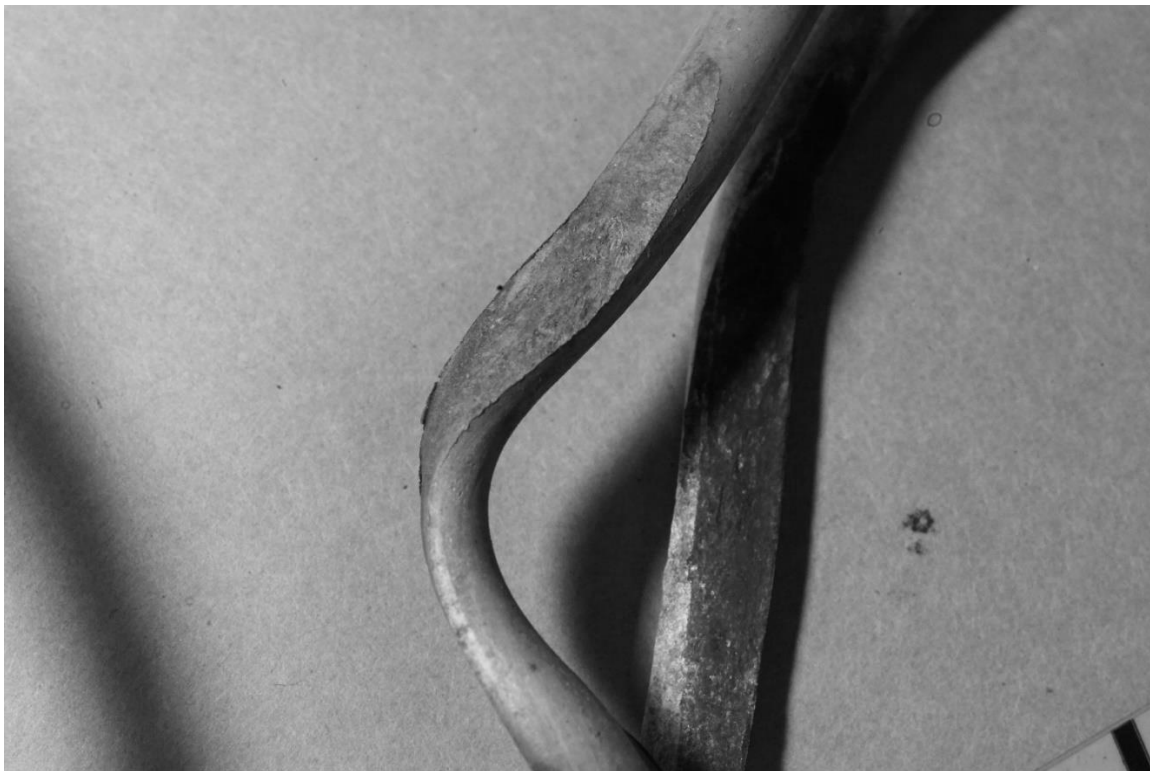
on the ground under the distribution line exhibited evidence of mechanical wear and electrical arcing (refer to Figure 21 and Figure 22).

**Figure 21. Failed lashing from the east conductor with evidence of wear and electrical arcing.**

**Figure 22. Failed lashing from the east conductor with evidence of wear and electrical arcing.**

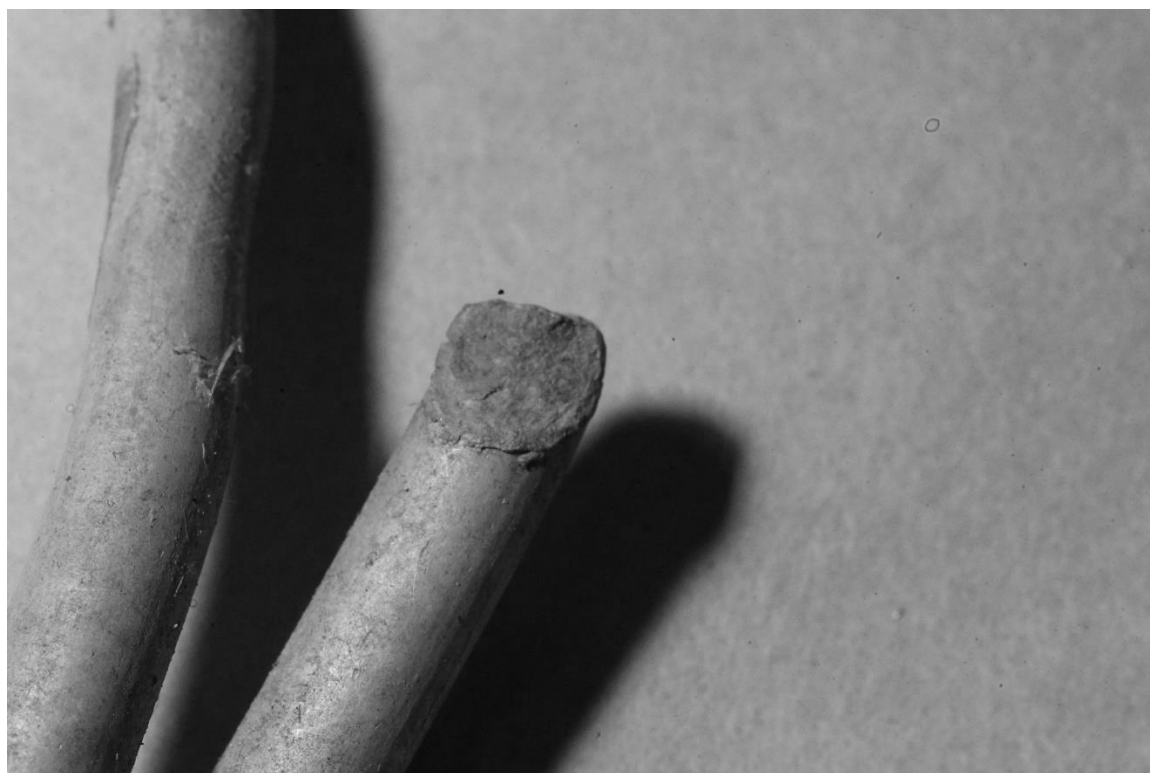
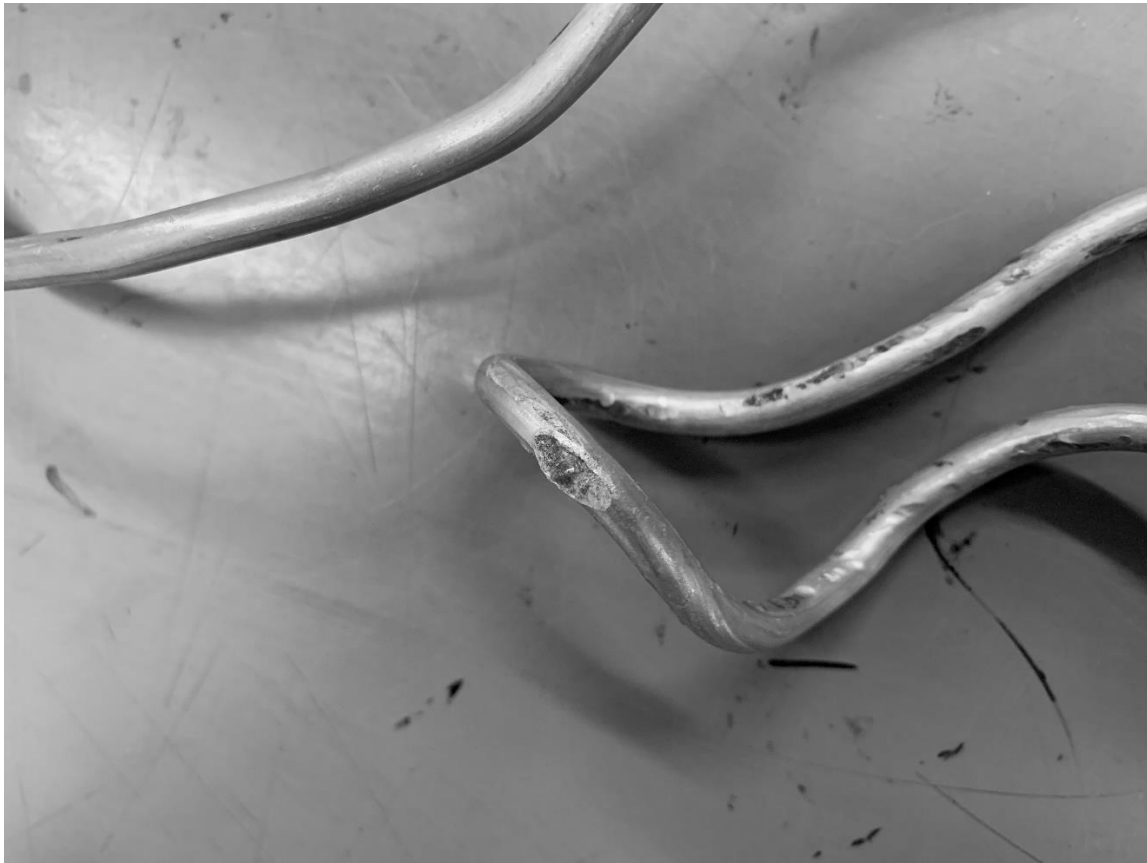
**Figure 23. Evidence of electrical on the failed lashing.**

**Figure 24. Evidence of electrical on the failed lashing**

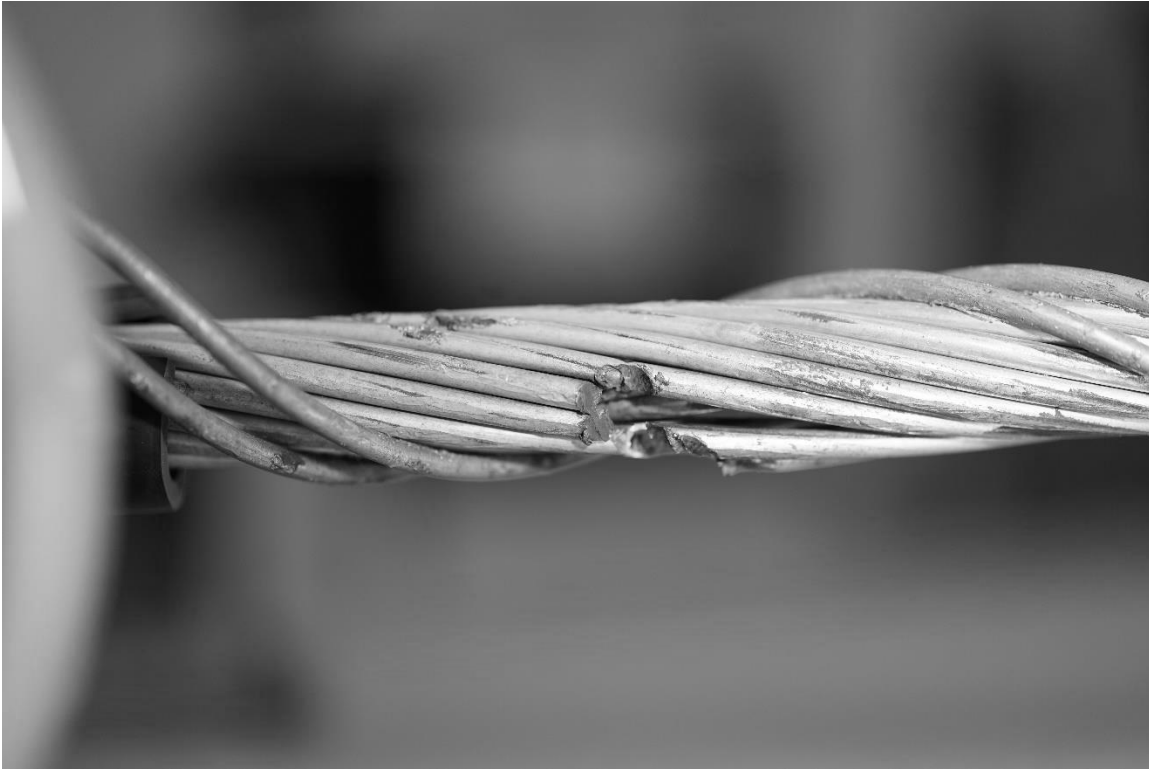
The conductors were examined in the field and in the Jensen Hughes laboratory. All conductors exhibited evidence of electrical arcing (refer to Figure 26 through Figure 31). One area of the center conductor was missing a large (a few grams) particle of aluminum conductor (refer to Figure 28, Figure 30, and Figure 31). Furthermore, arc damage was observed on the lashing that had held the eastern conductor in place and the arcing would have contributed hot material to the hot particle production. Prior testing done by Jensen Hughes has shown that a hot particle with a mass of a few grams would have been large enough, hot enough, and near enough to a susceptible fuel bed to create ignition.

**Figure 31. Electrical arcing on the center phase conductor.**
