## MARSHALL MESA TRAILHEAD FIRE INVESTIGATION REPORT

File Name: Marshall Mesa Trailhead Fire  
Date of Incident: December 30, 2021  
Location: Intersection of Marshall Road (SH170), Eldorado Springs Drive, and Foothills Highway (SH93)  
JH File Number: 1A3894001

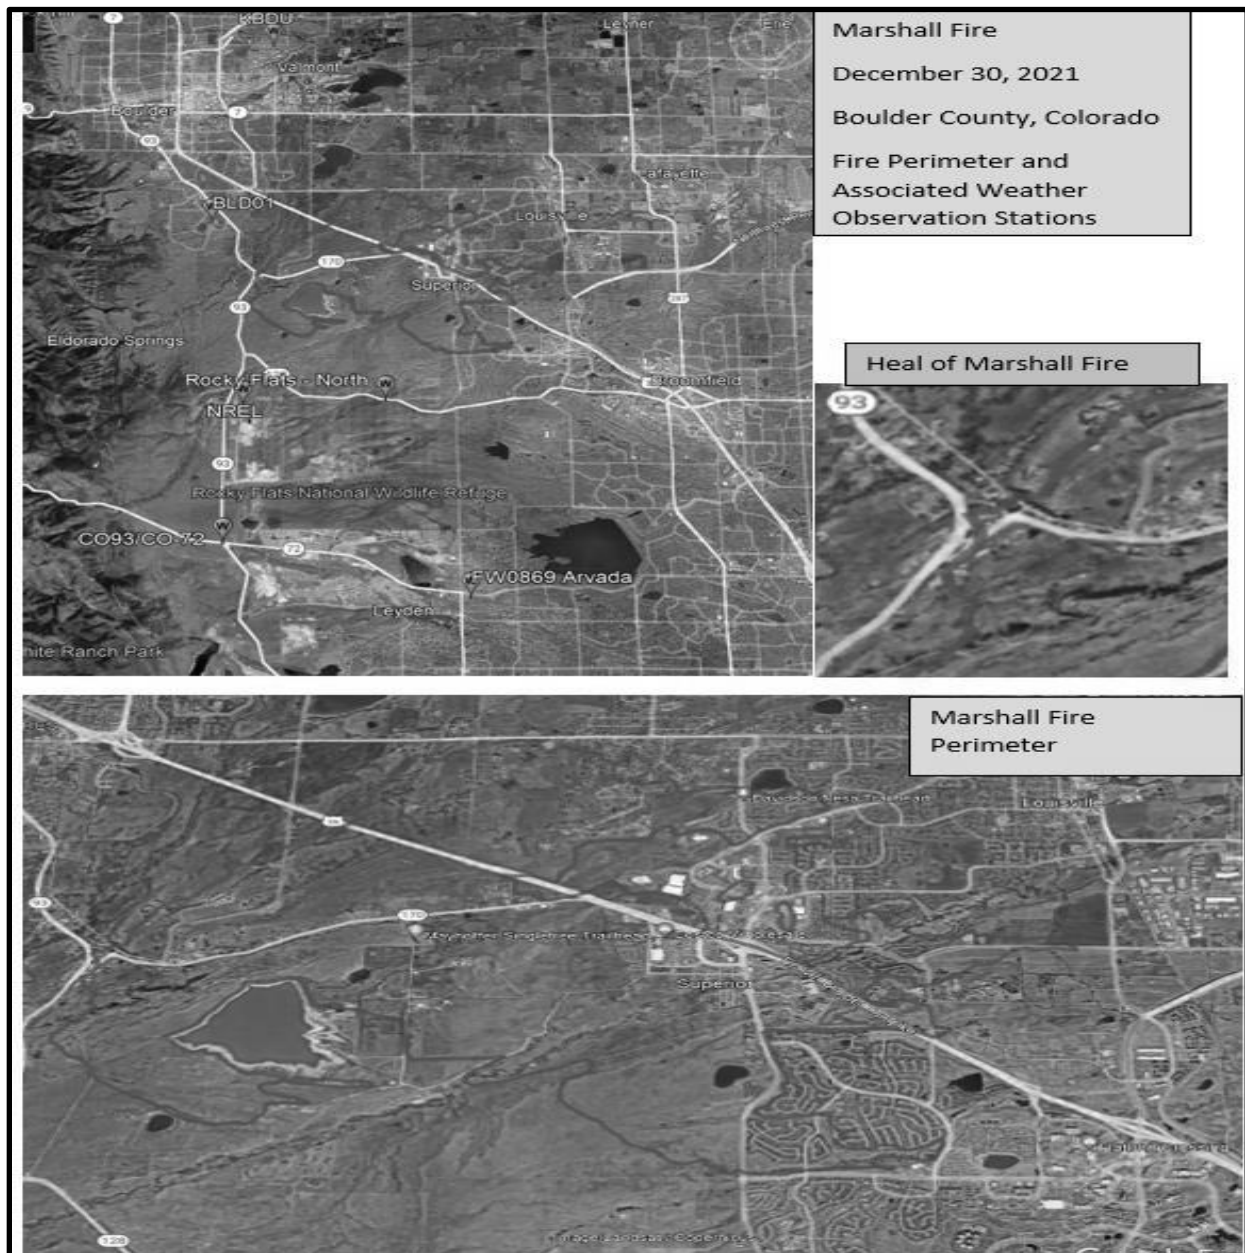
Figure 2. Excerpt from the Wildland Fire Origin and Cause Supplemental Incident Report, page 16.

The USDA Forest Service “Wildland Fire Origin and Cause Supplemental Incident Report” (referred to as the FS O&C Report in this report) included a number of descriptive fire scene sketches on pages 16-20 which are included below as Figure 2 through Figure 5. The Marshall fire had three origin points. Referring to Figure 5 below, SAO #1 and SAO #2, were near and downwind from the Xcel Energy pole identified during preliminary investigation as “Pole MP2.” Subsequent investigation revealed that “Pole MP2” was identified by Xcel Energy as Pole Number 432056196. For ease of reference, I will refer to the pole as Pole MP2.

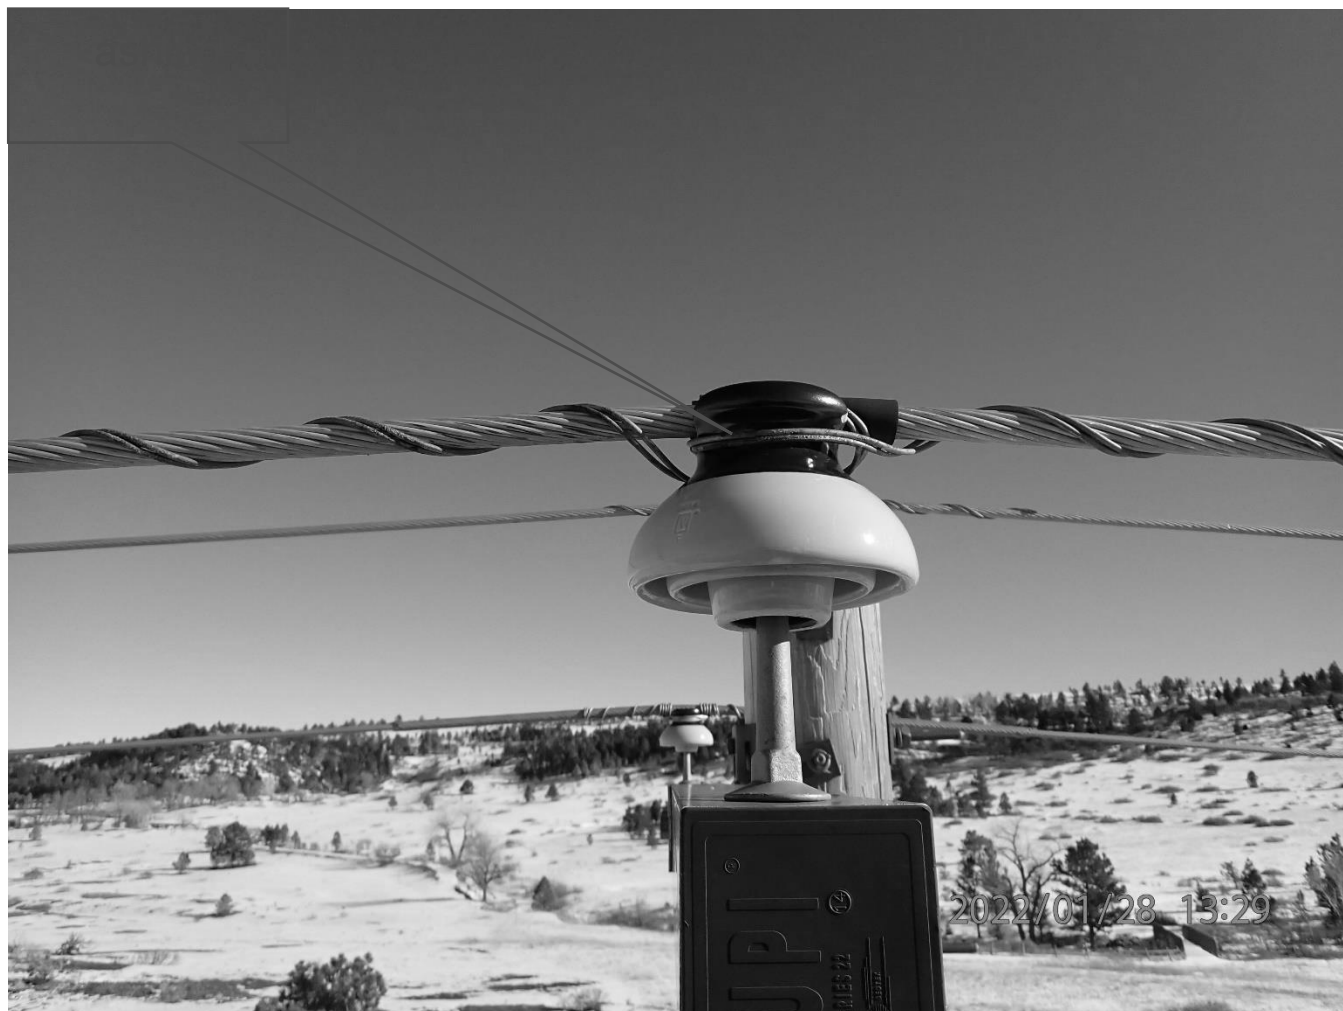
The Xcel Energy distribution line in the area of SAO #2 was supported by Pole MP2 (refer to Figure 16 through Figure 18.) The Xcel Energy system in the area was a three-phase, 33kV distribution line. Each conductor of the three-phase line was supported by a pin-type porcelain insulator and the conductors were lashed to the insulators with aluminum lashing wire (Figure 17 through Figure 20 ). The lashings from the east conductor that were found

**Figure 19. West phase pin insulator.**

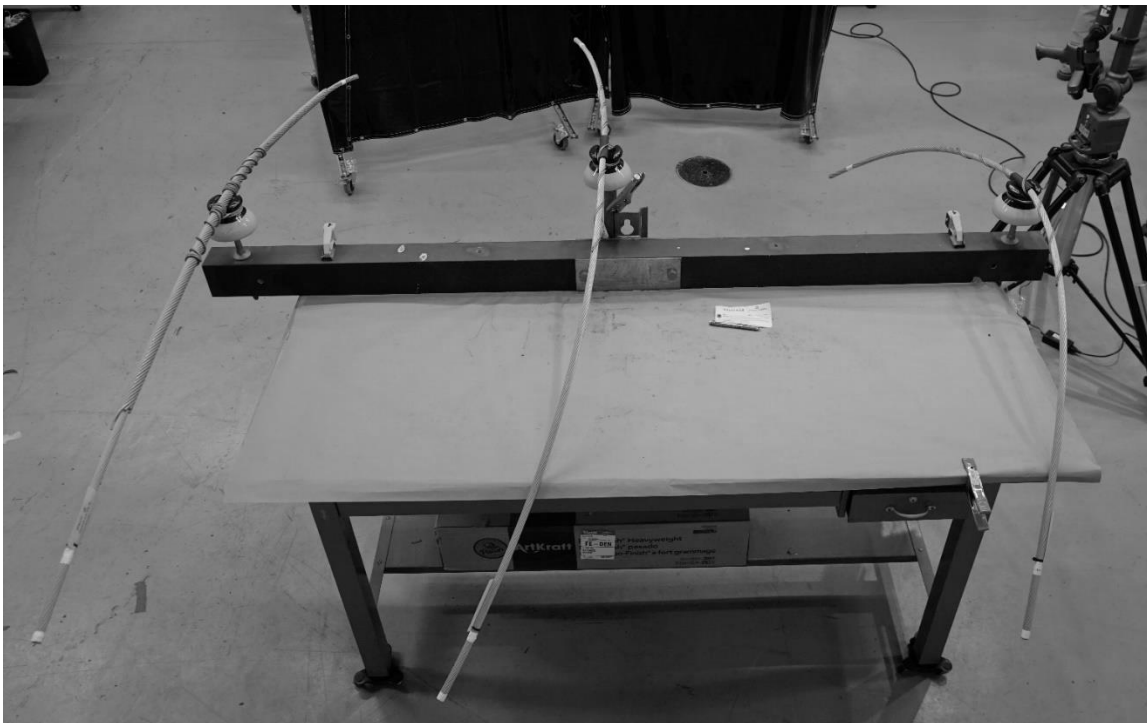
**Figure 25. Crossarm and conductors reconstructed in the laboratory.**
